Please follow the below images and accompanying instructions to ensure the frame for the 561 Waste Management System is correctly installed. Failure to do so will result in the frame being too large for the buckets, which will result in the buckets falling through the frame.

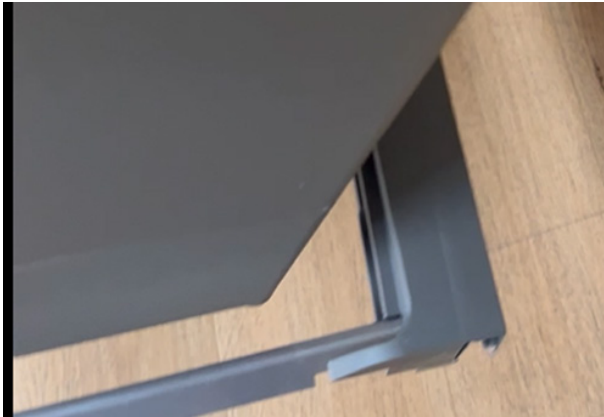
The empty space in the picture below shows that the frame has not been correctly installed as the plastic profile has not been clicked into the inox frame.

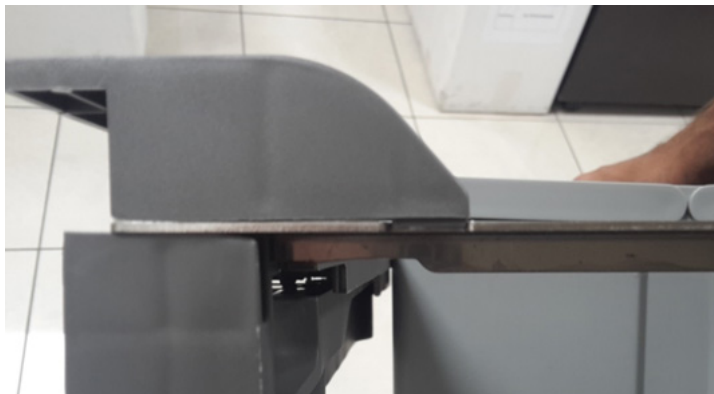
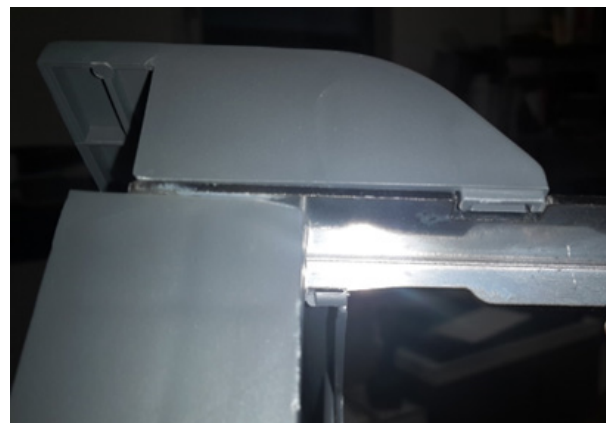
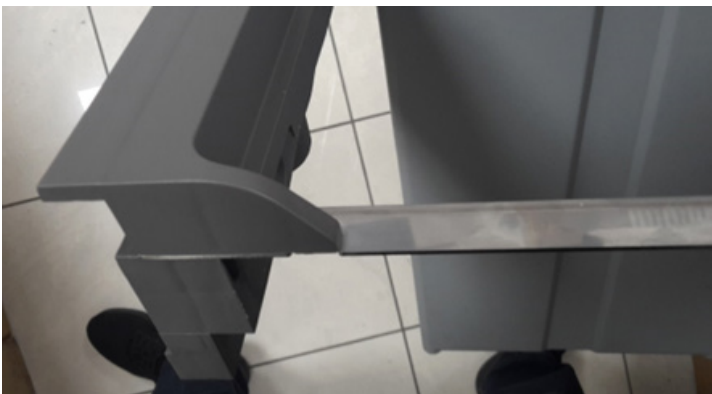
The following images show the correct installation.
